GEOLOGICAL INTERPRETATION OF THE ST. FRANCIS DAM DISASTER SITE

Location:
San Francisquito Cyn.
Santa Clarita, CA

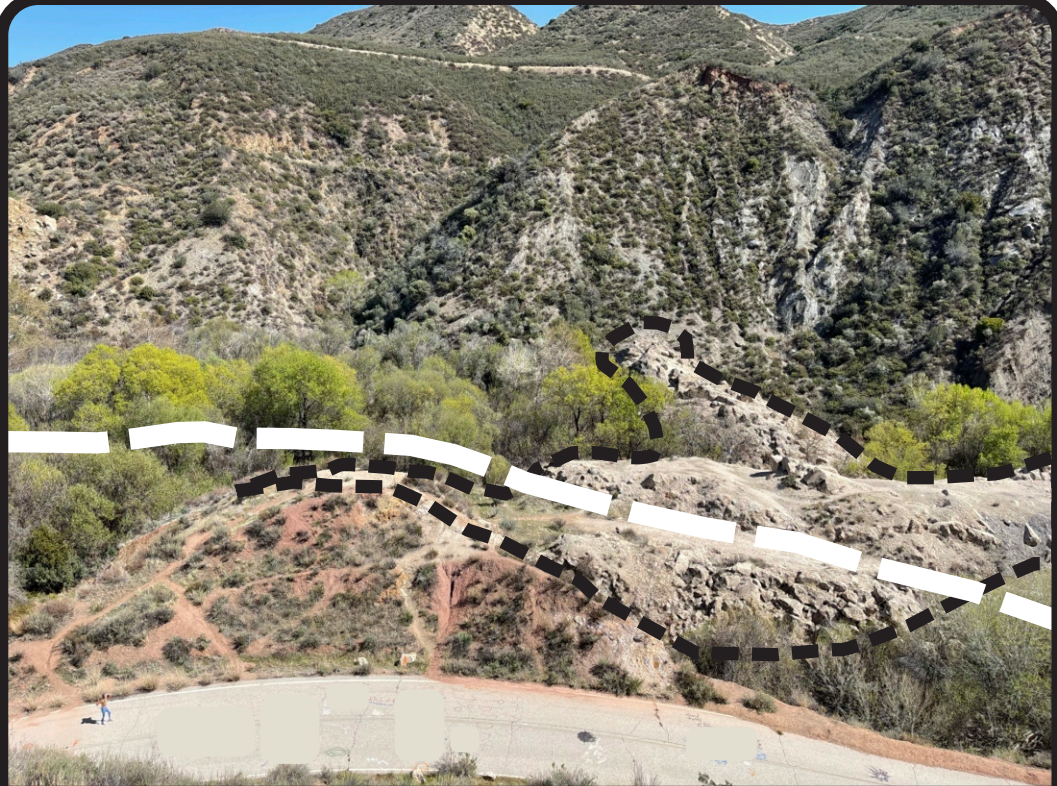
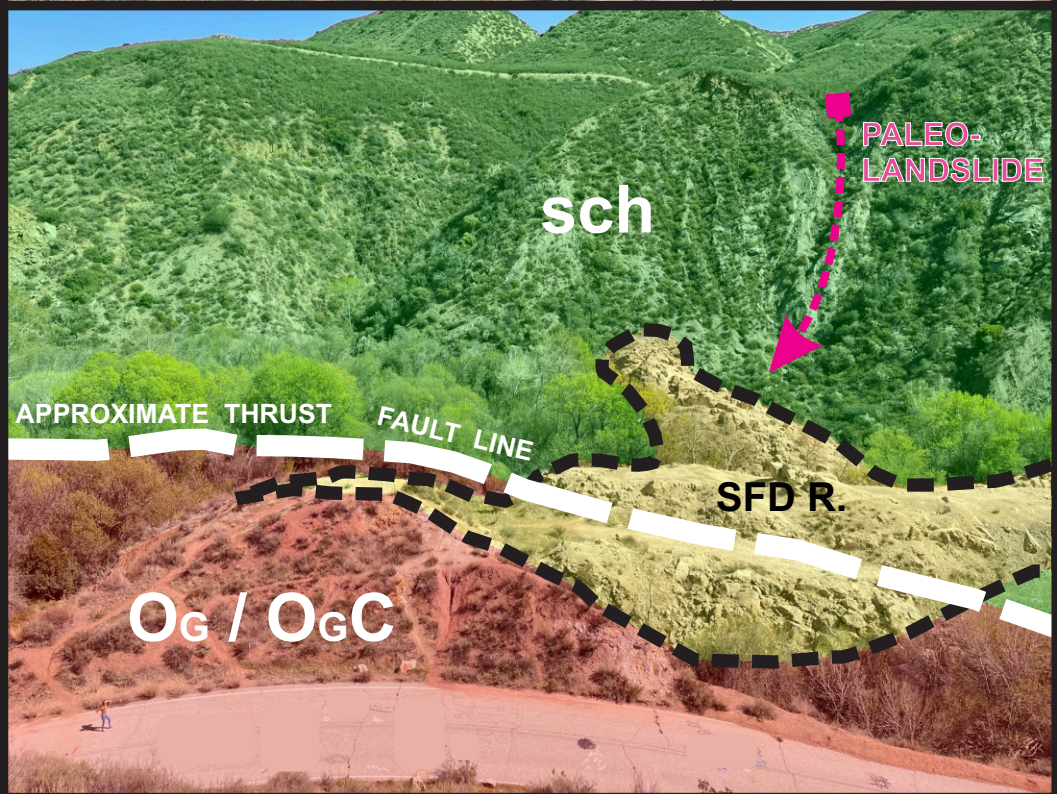
- sch sch: Pelona Schist
- Og / OgC Og/OgC: Sespe Formation
- SFD R. SFD R.: St. Francis Dam Ruins

Geology Interpretations By:
Geo Forward, with references to the
California Department of Conservation
Current Regional Geologic Map Series (1981-Present)
